DYNAMIC SCIENCE, INC.
In-Depth Accident Investigation

Case Number: DS96005

14. Sponsoring Agency Code	
15. Supplemental Notes			
16. Abstract An unrestrained and out of position 3 year old female, located at the right front seating position, sustained fatal head and neck injuries from contact with the deploying front right passenger's air bag and air bag module flap. Vehicle 1, a 1995 Chevrolet Geo Metro LSi three-door, was being driven north, in the northbound travel lane at a speed estimated to have been between 48 and 56 km/h (30 and 35 mph) by the 15 year old female driver who was not restrained by the available three-point, manual lap/shoulder restraint. Occupant 2, a 15 year old female, was seated in the right front seating position unrestrained by the available three-point, manual lap/shoulder restraint. Occupant 3, a 3 year old female (the case occupant) was seated, unrestrained on the lap of Occupant 2 in the front right seating position. As Vehicle 1 was negotiating a left turning curve, the driver for unknown reasons drove off the east edge of the roadway. Upon departing the roadway, Vehicle 1 continued in a relatively straight northeasterly path across a residential l

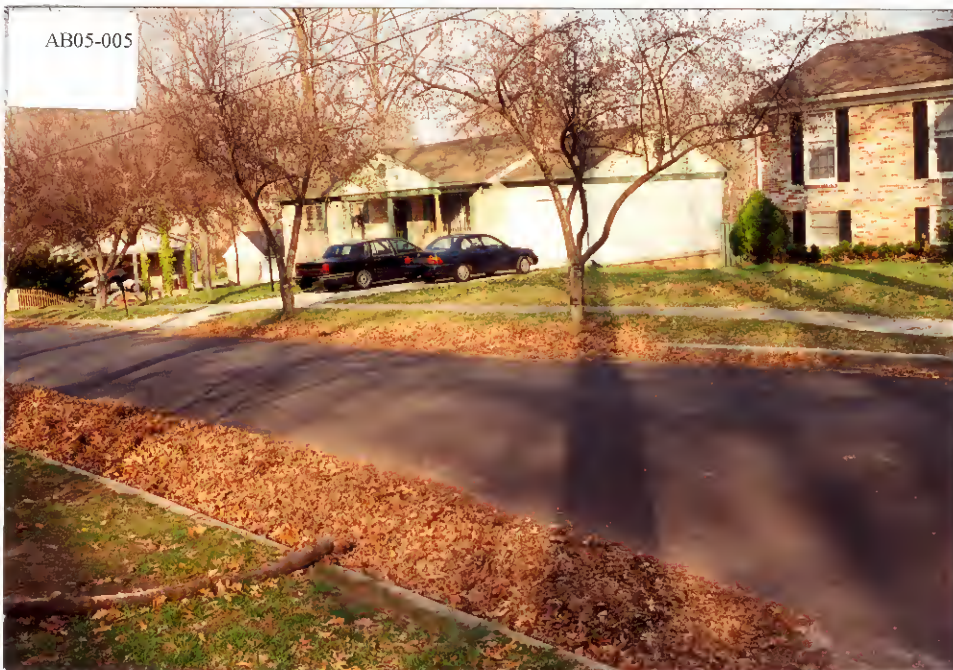
AB05-005

For unknown reasons, Vehicle 1 departed the east edge of the roadway, traveled a straight northeasterly path across a sidewalk, a lawn, and a concrete driveway leaving rolling left and right front tire marks for a distance of approximately 18 m (60 ft) with no evidence of braking (see Photos 6-12).

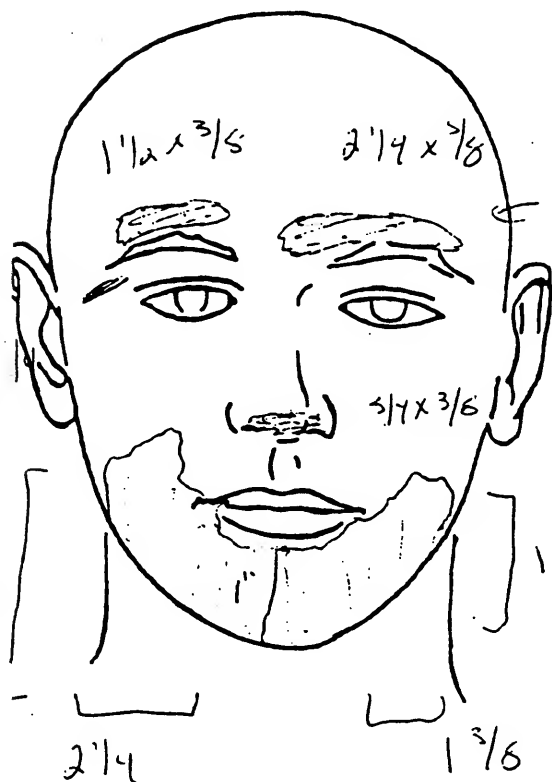
marked drying of
lips - both (V) & (L)
frenulum torn c
1/4 x 1/8 lac. of
midline lower lip

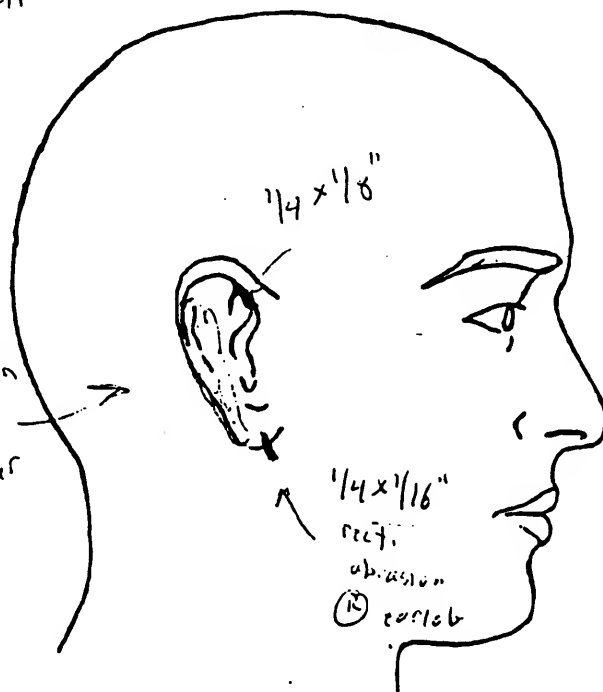
2 x 3/8
deep abrasion
on post.
lat. (R) ear

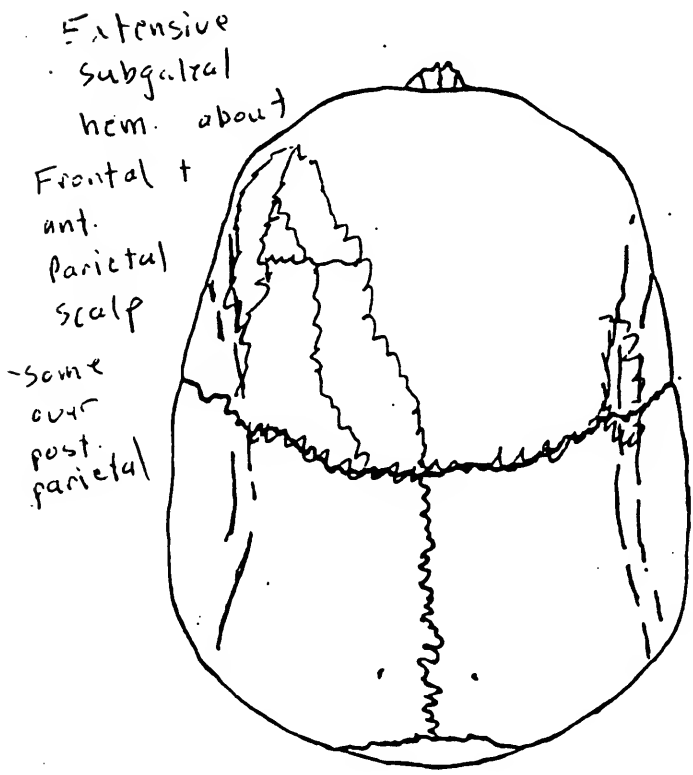
abrasion extends
from 1/2" (midline) to
1" ② side undersurface
of jaw.

Extensive
subgaleal
hem. about
Frontal +
ant.
Parietal
scalp
-some
over
post.
parietal
